Pre-Design Inspection Summary Report

Artistic Printing

Former Vermiculite Intermountain Facility-SLC2

Libby Sister Sites (Asbestos Project)

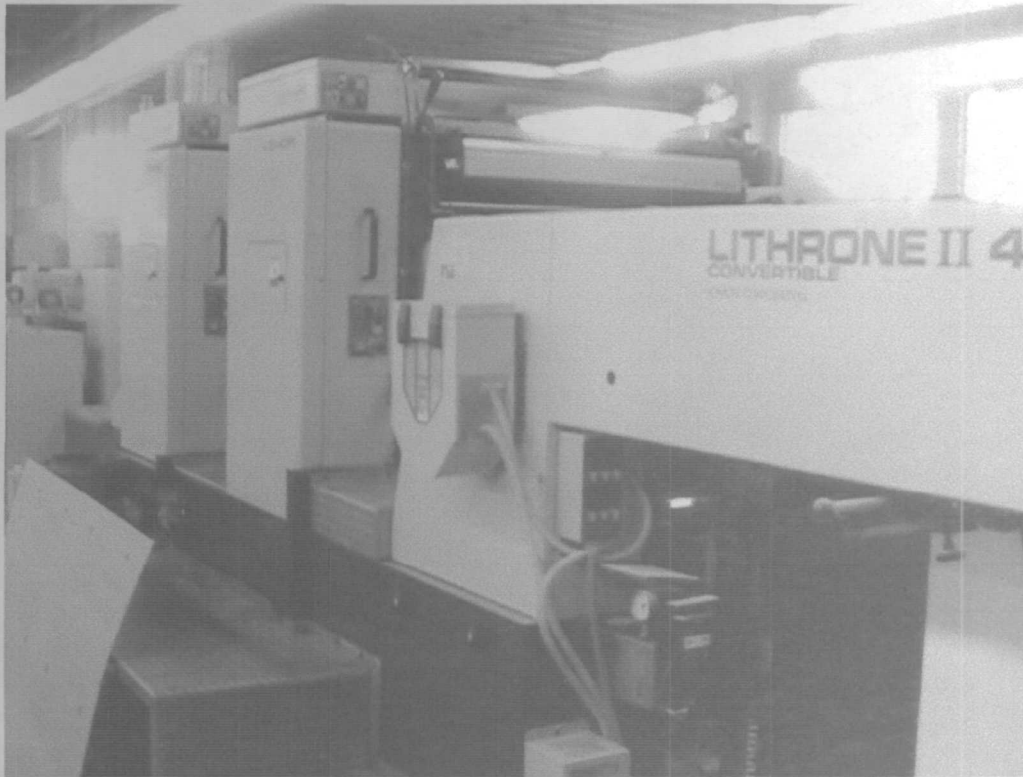
3. Two-color printing press in press room (looking southwest).

The press room contains three main pieces of printing equipment (Attachment A, photographs 1 through 4). These consist of a sheeter, six-color printing press, and a two-color printing press. Mr. Benson expressed concern for protection of the two printing presses during the removal operations. Specifically, he was concerned that debris and/or dust would be introduced to some of the printing press intricacies during cleanup and clearance activities. He suggested that the two printing presses be covered with poly sheeting before aggressive cleaning activities are conducted. The printing press machines are large and encompass most of the room. There are several control units and electrical conduits throughout. As part of the printing operation, corn starch is applied at various stages of the printing process. Because of this, there is a corn starch residue throughout most of the press room, especially around the perimeter of and underneath the printing presses. Effective cleaning methods for the printing presses may include vacuuming the machines with a backpack vacuum equipped with a high efficiency particulate air (HEPA) filter.

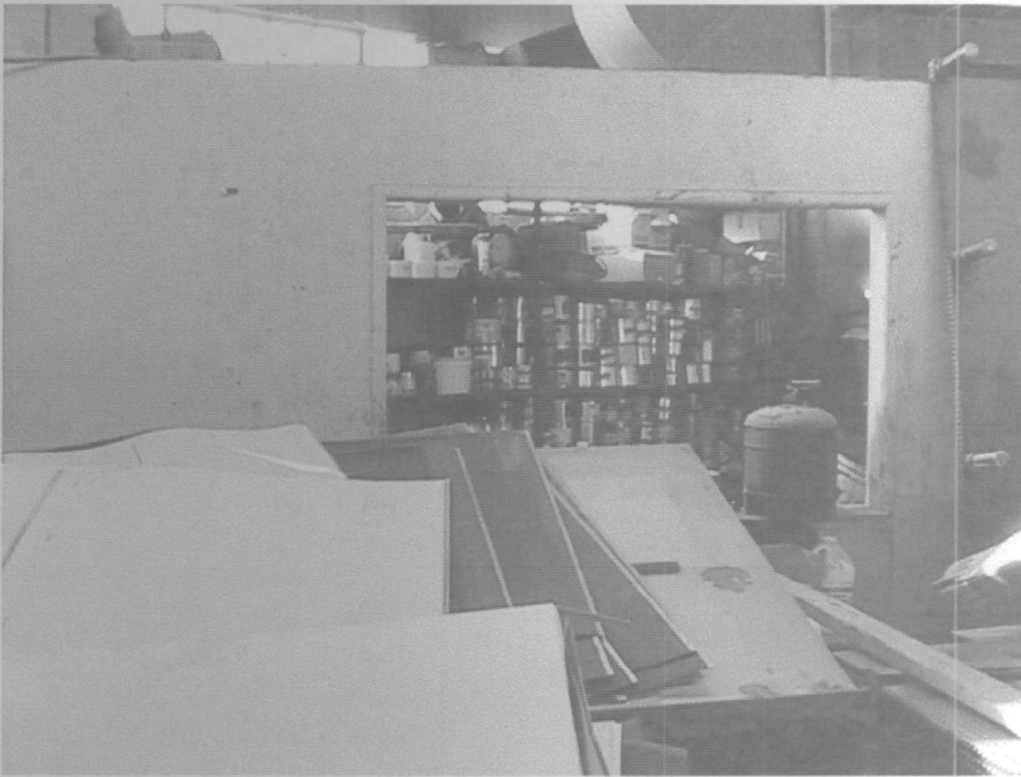
The ink room, located in the southwestern section of the press room, consists of an open air (i.e., no ceiling) room, measuring approximately 430 ft², sectioned off by a 10 ft high wood frame partition (Attachment A, photograph 5). The ink room is stocked with various sizes of cans of paint, solvents, and ink. It should be noted that some of the aforementioned products may be considered hazardous waste (for disposal purposes). Also within the ink room, there are miscellaneous tools (i.e., nuts, bolts, hoses, etc.) and work benches.

5. Ink room (looking west).

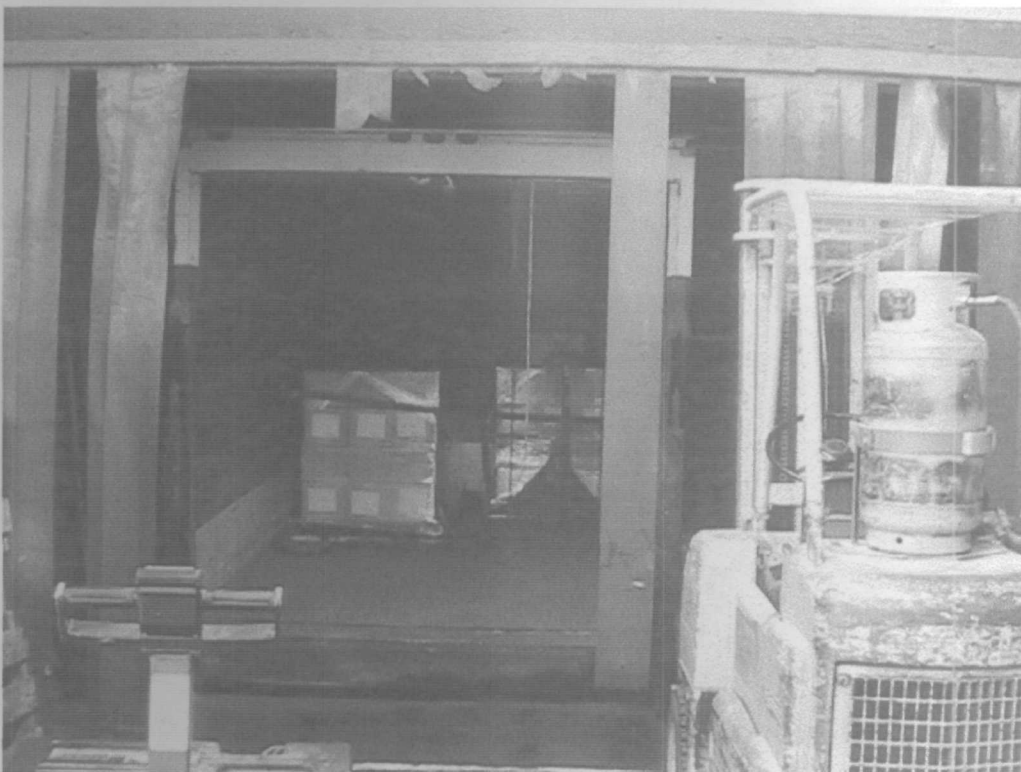
The loading dock is located on the north end of the press room and east of the office area (Figure 1). There is a 17.5 x 10 ft open entrance (no door) to the loading dock. There are vertical plastic strips separating the loading dock from the press room (missing some strips). The loading dock external entrance consists of a large 18 x 15 ft rollup bay door. The loading dock is used primarily for shipping and receiving inventory for the printing operation. There is no significant inventory stored in the loading dock.

8. West bay loading dock (looking north). Note vertical plastic strips.

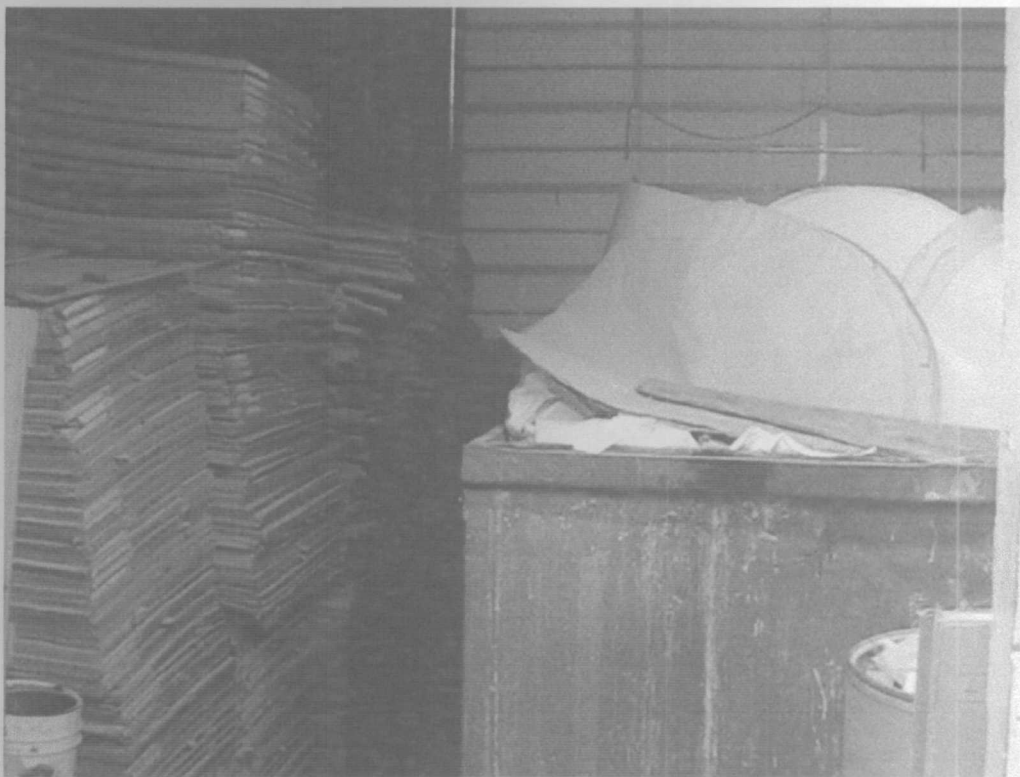
There is a storage area in the northern section of the binding room (Attachment A, photograph 11). This is where the main inventory for the printing operation is stored. Another loading dock is directly west of the storage area. There is a 7 x 5 ft door along the southern wall of the loading dock. The loading dock external entrance consists of a roughly 8 x 10 ft sliding bay door. This loading dock is primarily used to store film negatives, an antique car, delivery truck, and miscellaneous files (Attachment A, photograph 9). In addition, the room is used to store the main trash receptacle (dumpster).

9. East bay loading dock (looking north). Note the stacks of negatives in case along west wall.

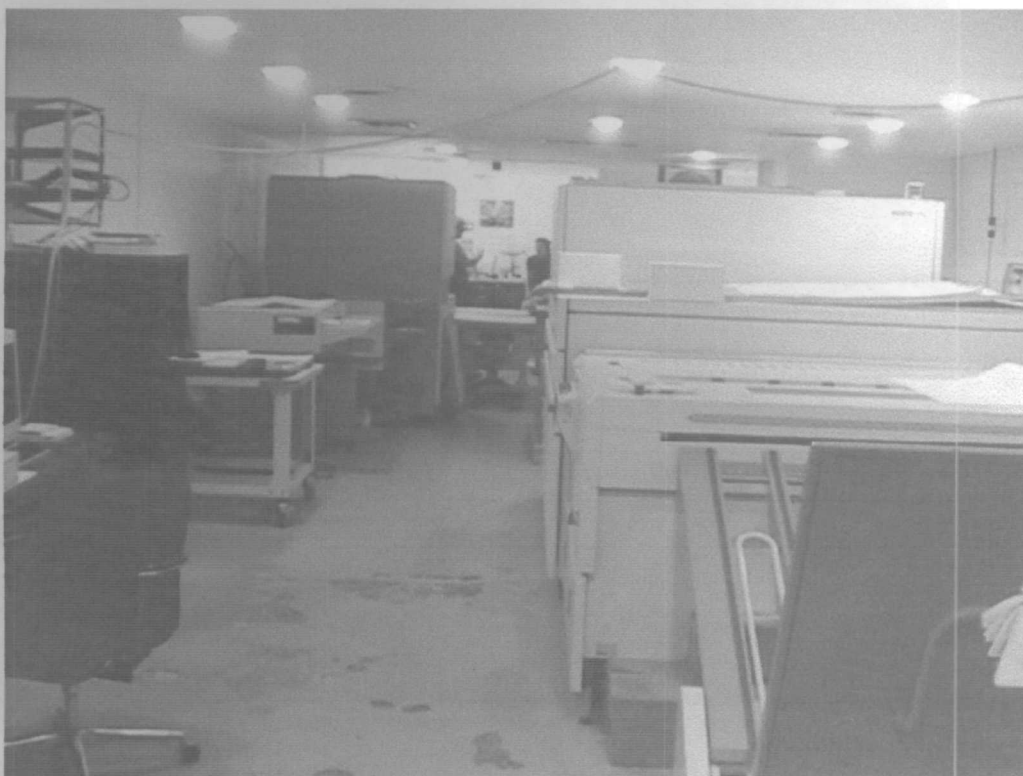
The walls and ceiling of the pre-press room consist of painted sheetrock and the floor is finished concrete (Attachment A, photograph 10). There is a separate room in the southern end of the pre-press room that serves as a black room (film development). There are two entrances to the pre-press room. These consist of two swinging doors along the north wall, leading to the binding room and a proper doorway in the western wall, leading to the press room. There are no windows within the pre-press room.

10. Pre-press room contents (looking south).

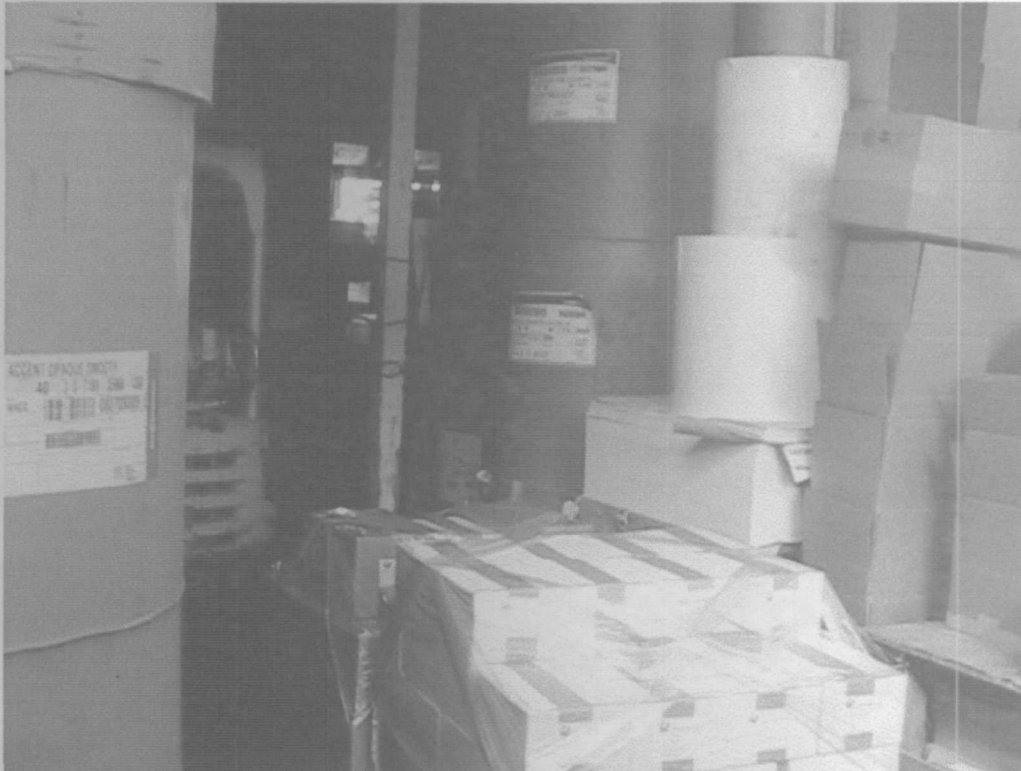
11. Storage area in northeast corner of binding room (looking northeast). Note inventory of paper and boxes of miscellaneous supplies.

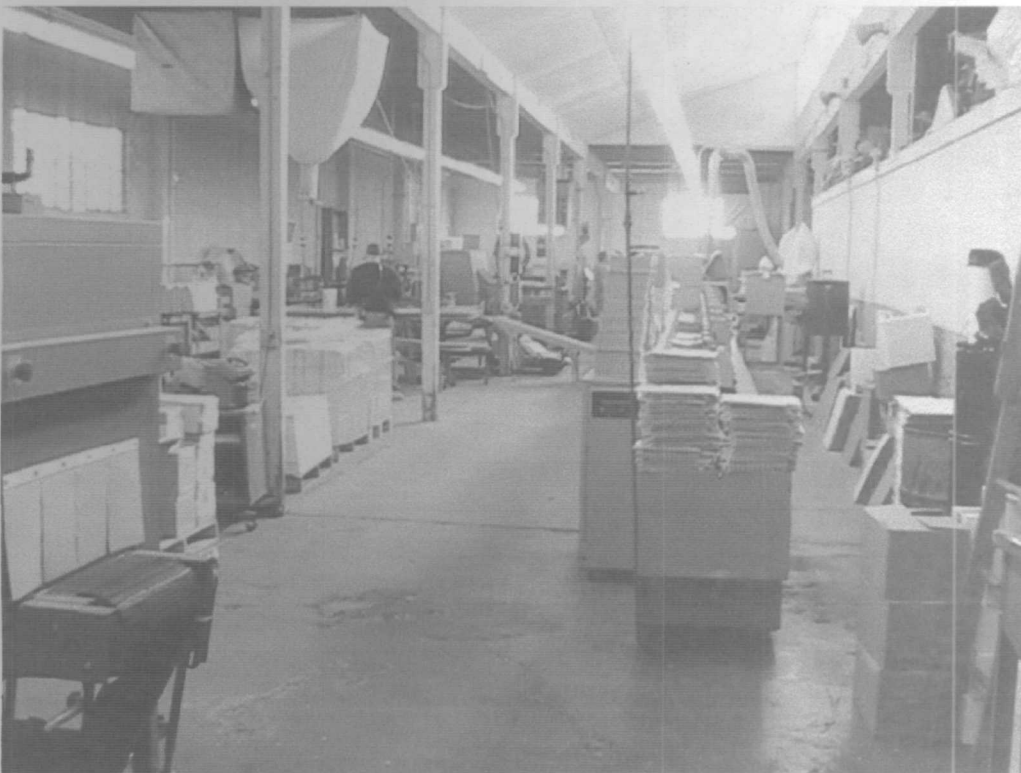
The finishing equipment includes an automatic folder, binder, collator, shrink wrap oven, and a cropping machine (Attachment A, photographs 12, 16, and 17). In addition, there are sheets and rolls of paper stored in the binding room. The employee break area is located in the southeastern section of the binding room. There are no walls separating the break area which includes a folding table, chairs, microwave, and a soft drink machine.

12. Binding room contents (looking south). Note pre-press room on right side of picture and pitch in roof.

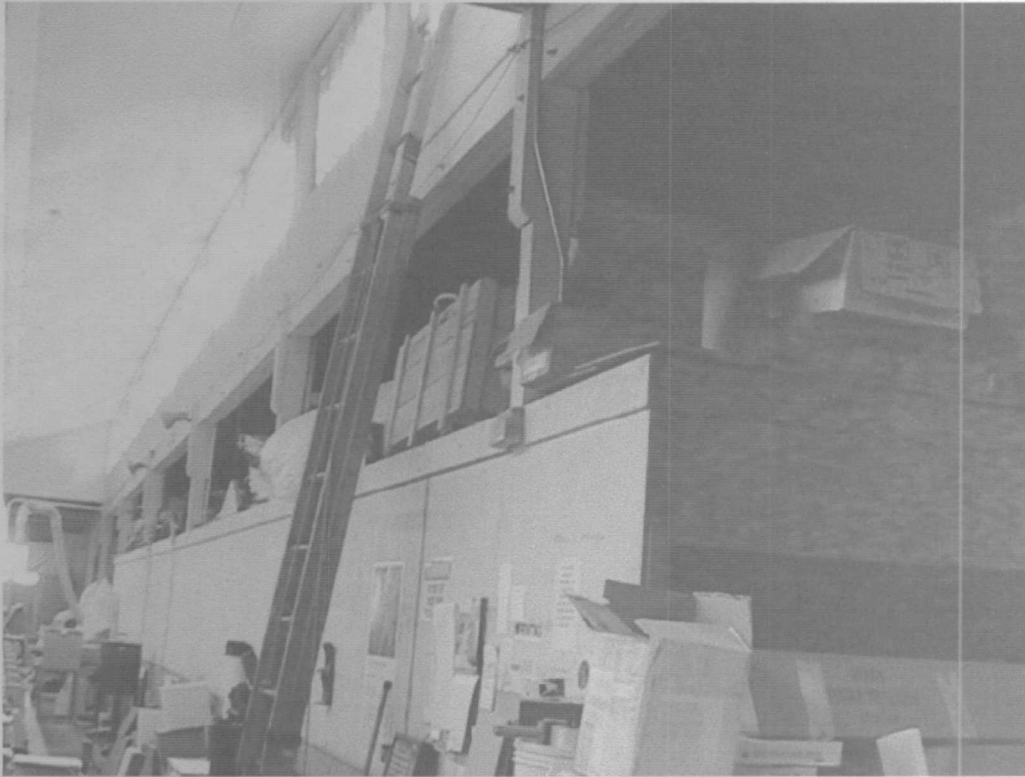
The pre-press room is located within the binding room (Section 2.1.3). This room is used to generate plates to be used in the printing process. It consists of a wood frame (painted plywood) tenant improvement and is considered to be a separate functional space from the binding room. It measures 1,380 ft² with 8.5 ft high ceilings. The approximately 5 ft high space above the pre-press room ceiling is used for storing

miscellaneous items (i.e., boxes, files, etc.) and is considered common airspace with the binding room. The total volume of the pre-press room is approximately 11,730 ft³.

13. Exterior walls of pre-press room (looking southwest). Note items stored on roof of the pre-press room.

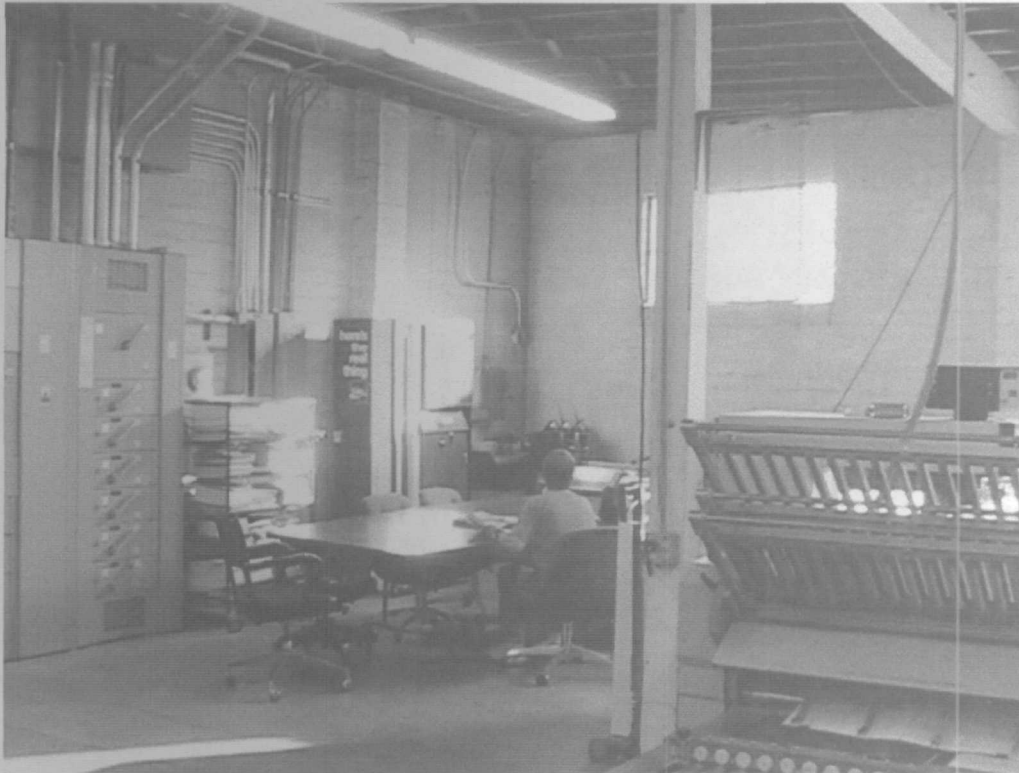
The primary electrical power shutoff box is located on the eastern wall of the binding room (Figure 1). There are several electrical wire conduits that service the office area and printing equipment in the press room. Water sources are located throughout the building.

15. Break area in southeast corner of binding room (looking southeast). Note main electrical panel along the east wall.

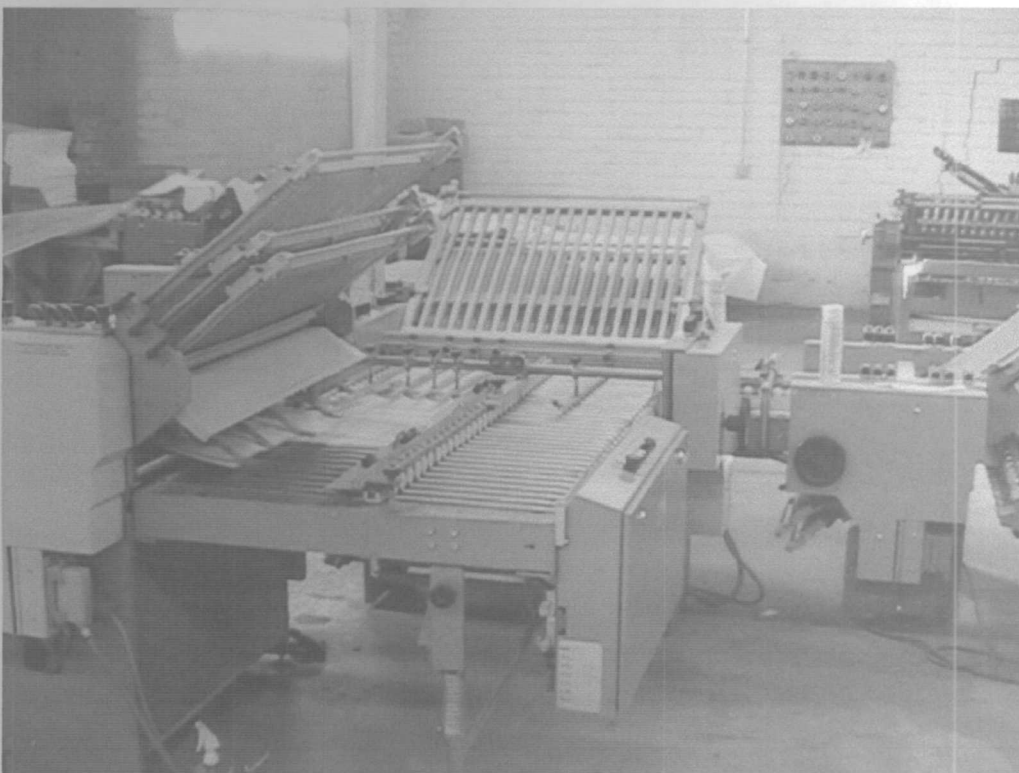
16. Automatic folding machine in southern portion of the binding room (looking west).
